## **HAZARDOUS MATERIALS SUMMARY REPORT**

### **Roof Replacement Project**

**Town Of Amherst  
Amherst Pelham Regional Middle School  
170 Chestnut Street  
Amherst, Massachusetts**

July 2025

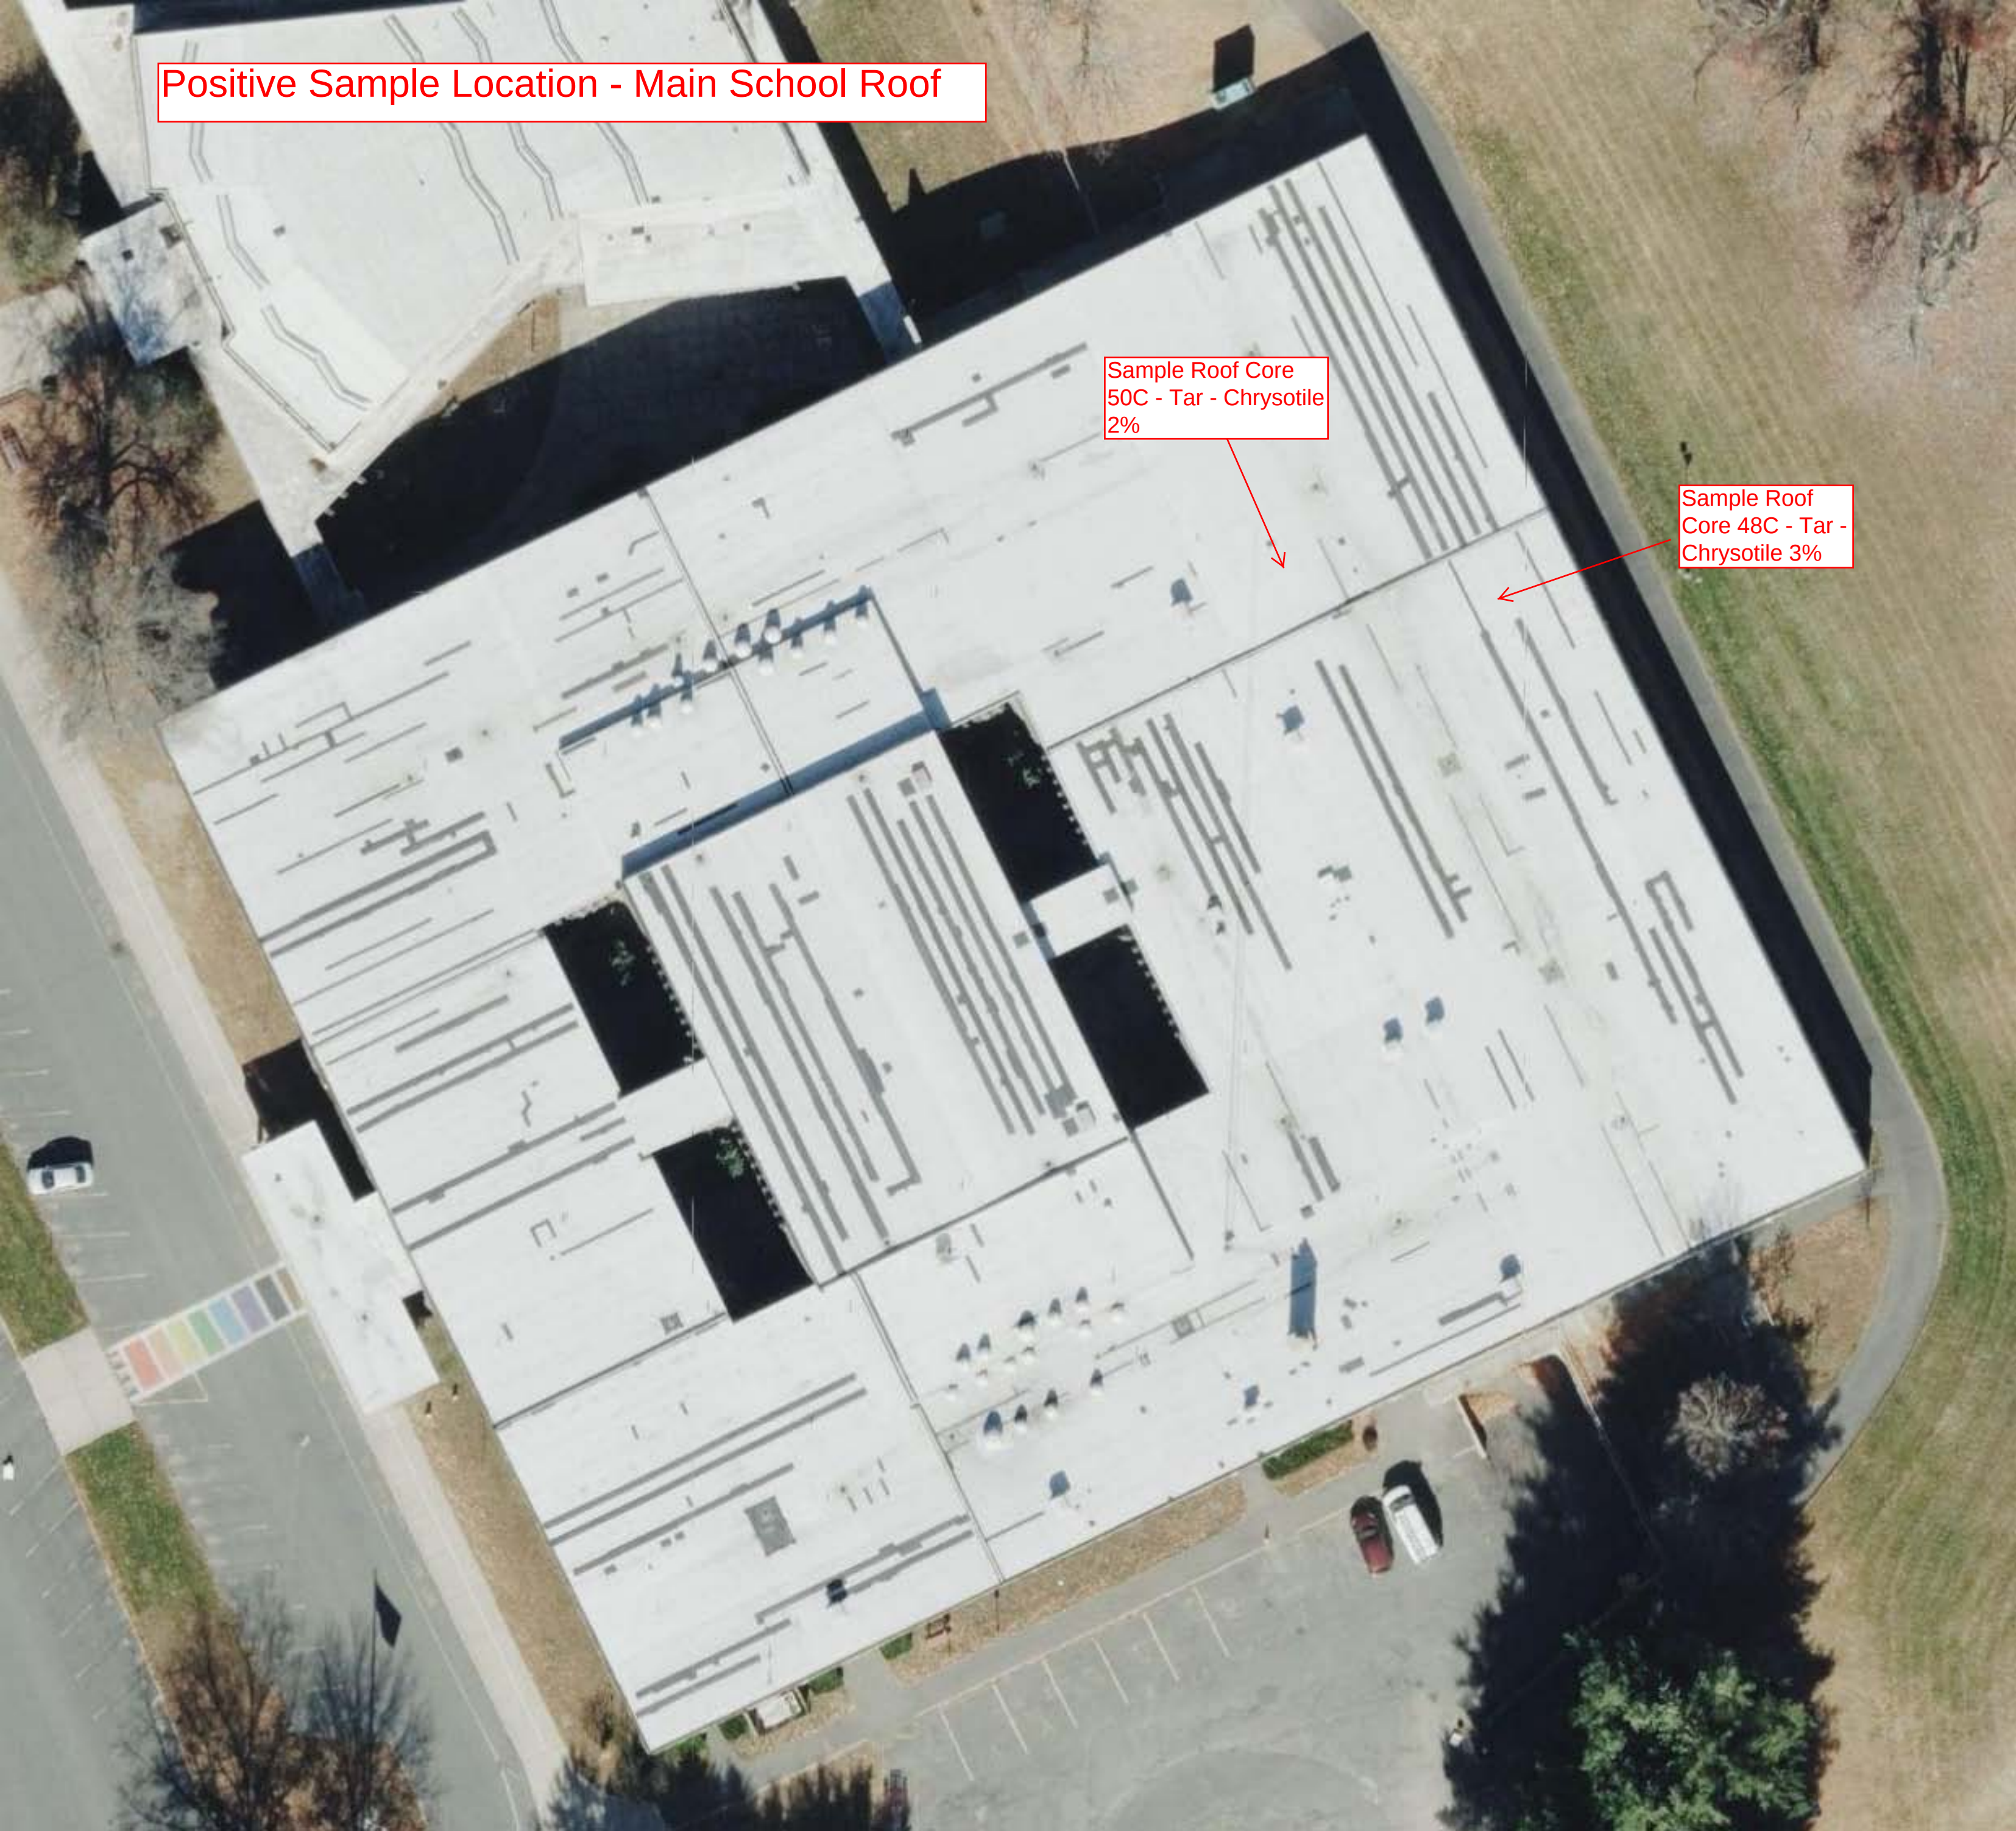
Sample Roof Core  
50C - Tar - Chrysotile  
2%

Sample Roof  
Core 48C - Tar -  
Chrysotile 3%

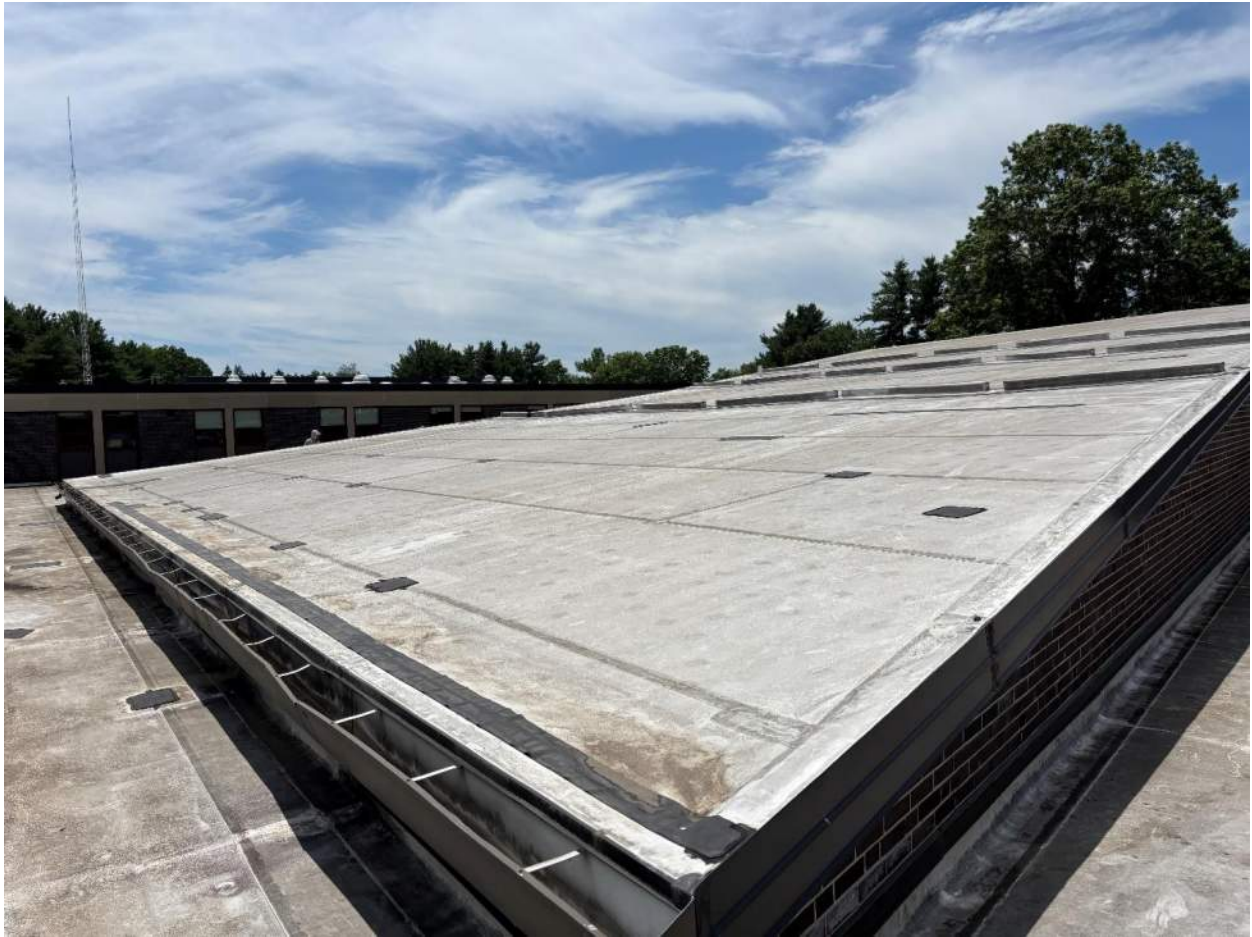
The gutter shown in this photo contains a Gray Sealant that is positive for ACM.

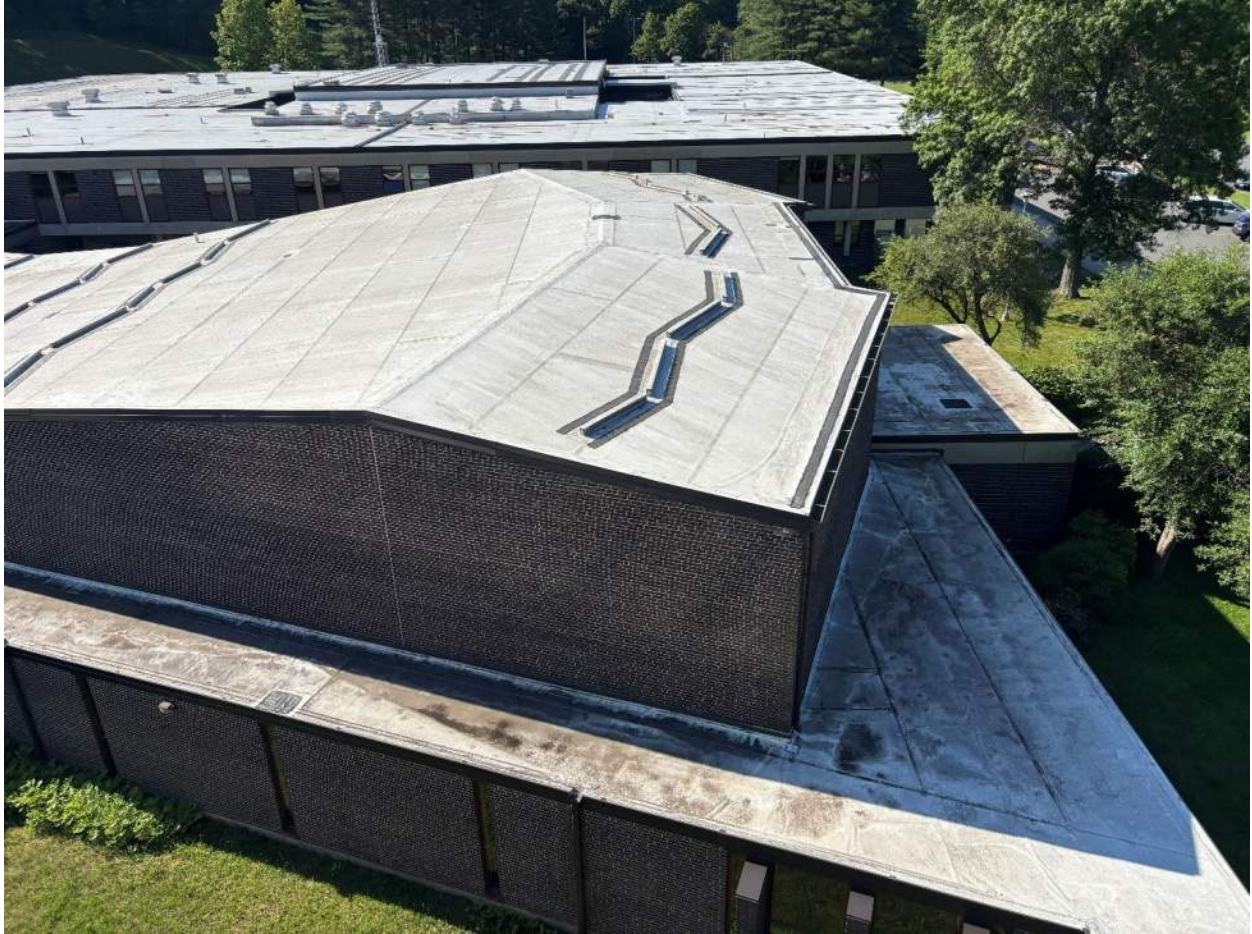
The gutter shown in this photo contains a Gray Sealant that is positive for ACM. (Gutters on either end of the auditorium roof)

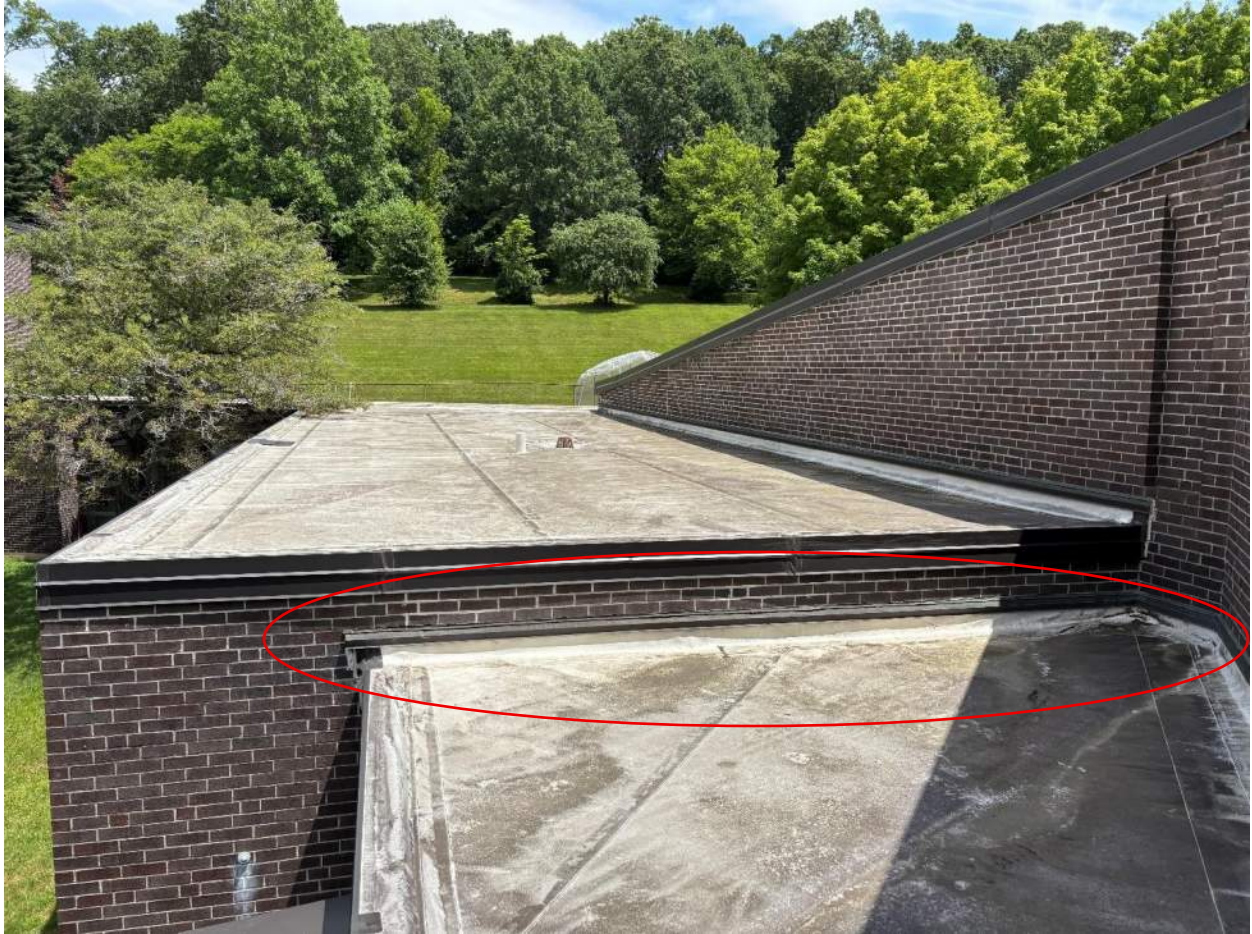
The curb (side wall) (circled in red) has a tar (vapor barrier) that is positive for ACM.

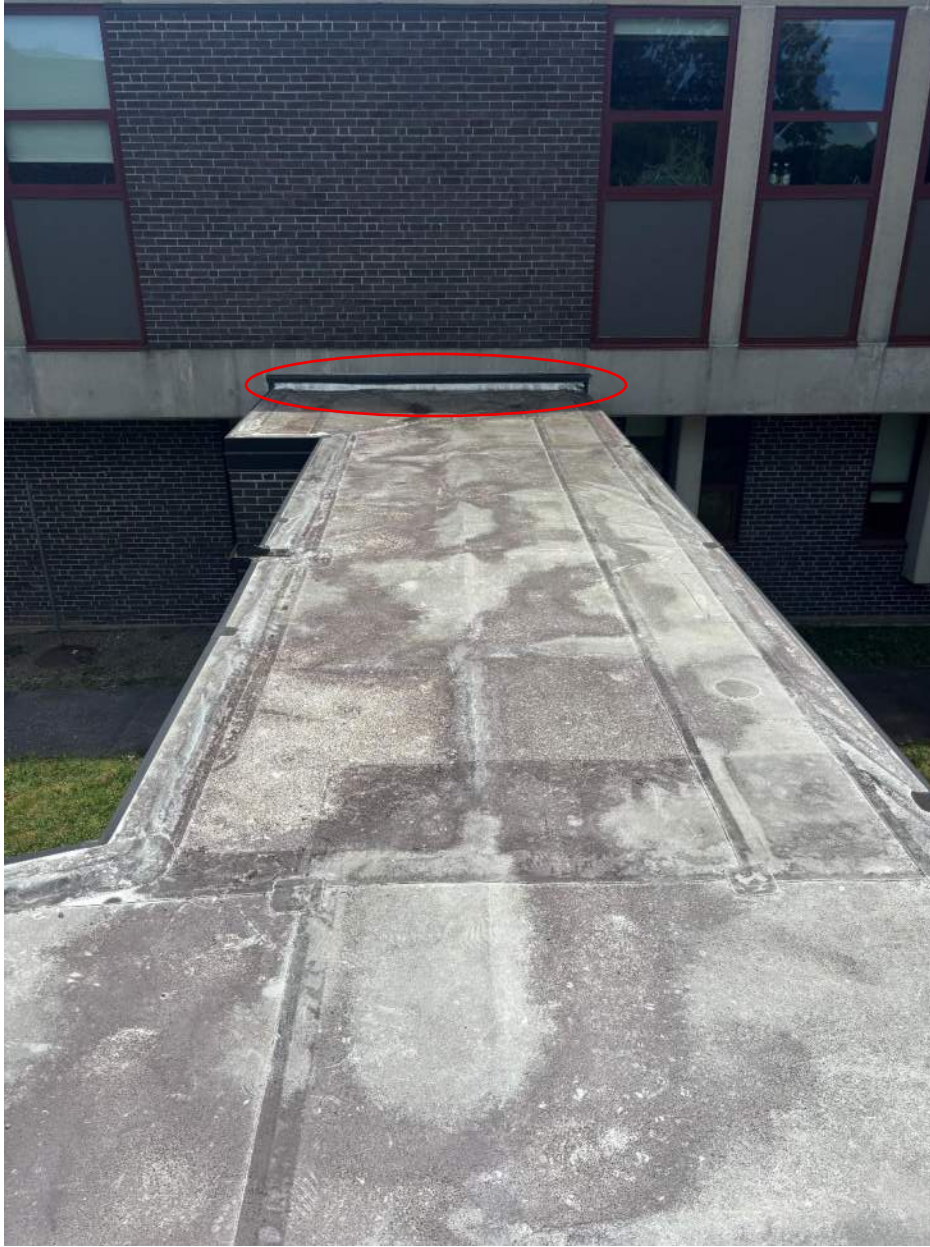
The curb (side wall) (circled in red) has a tar (vapor barrier) that is positive for ACM.

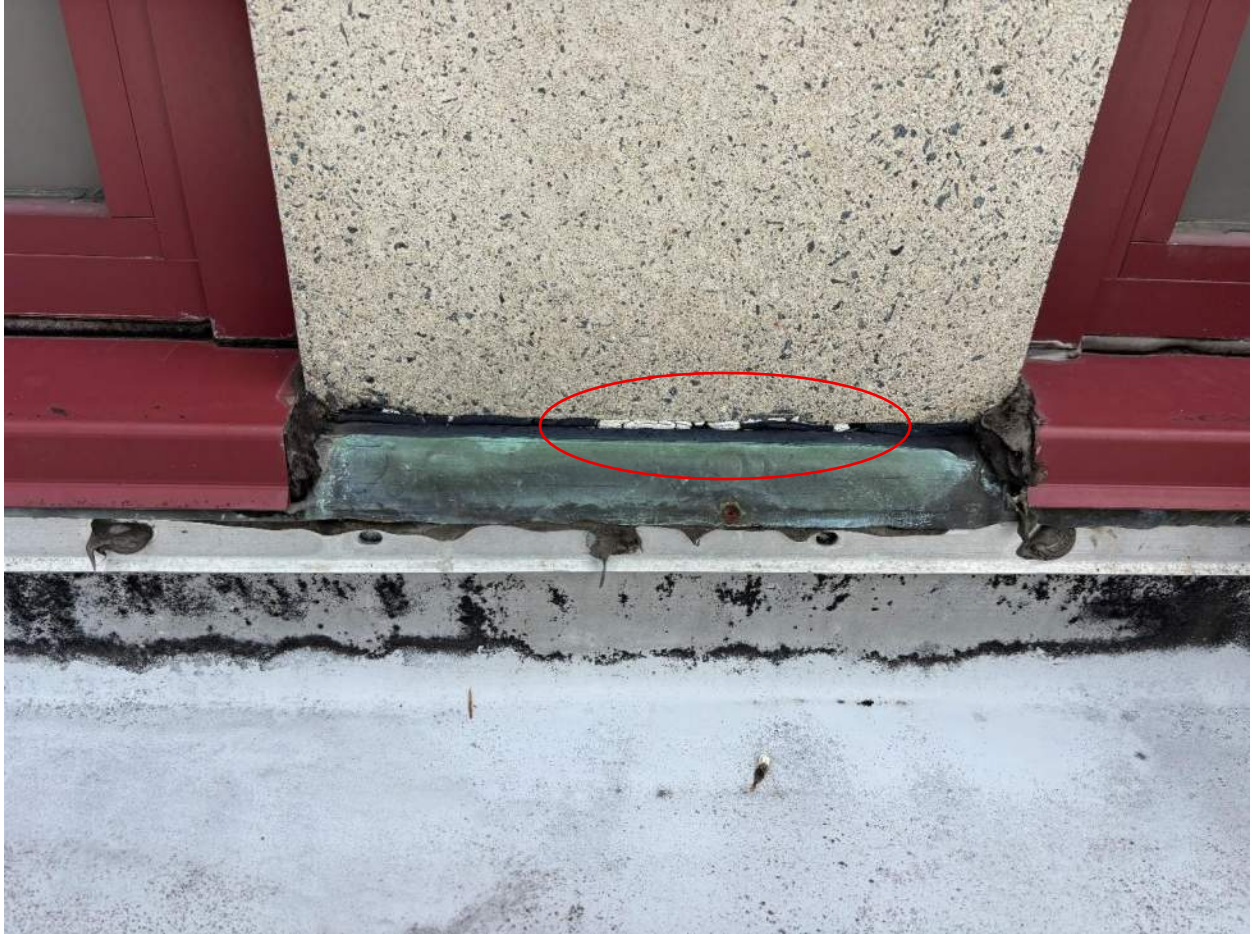
The white caulk (circled in red) shown in this photo is positive for ACM.

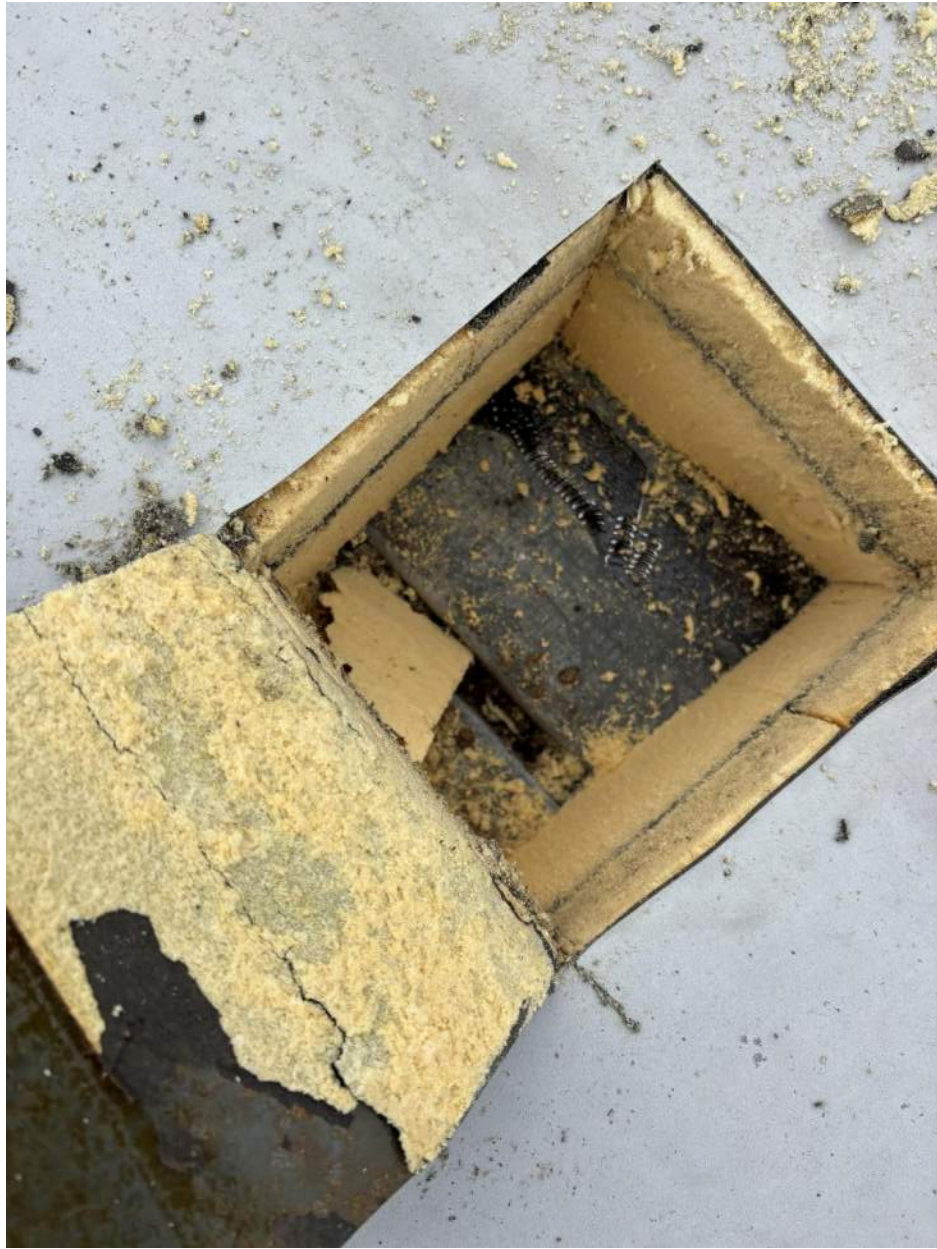
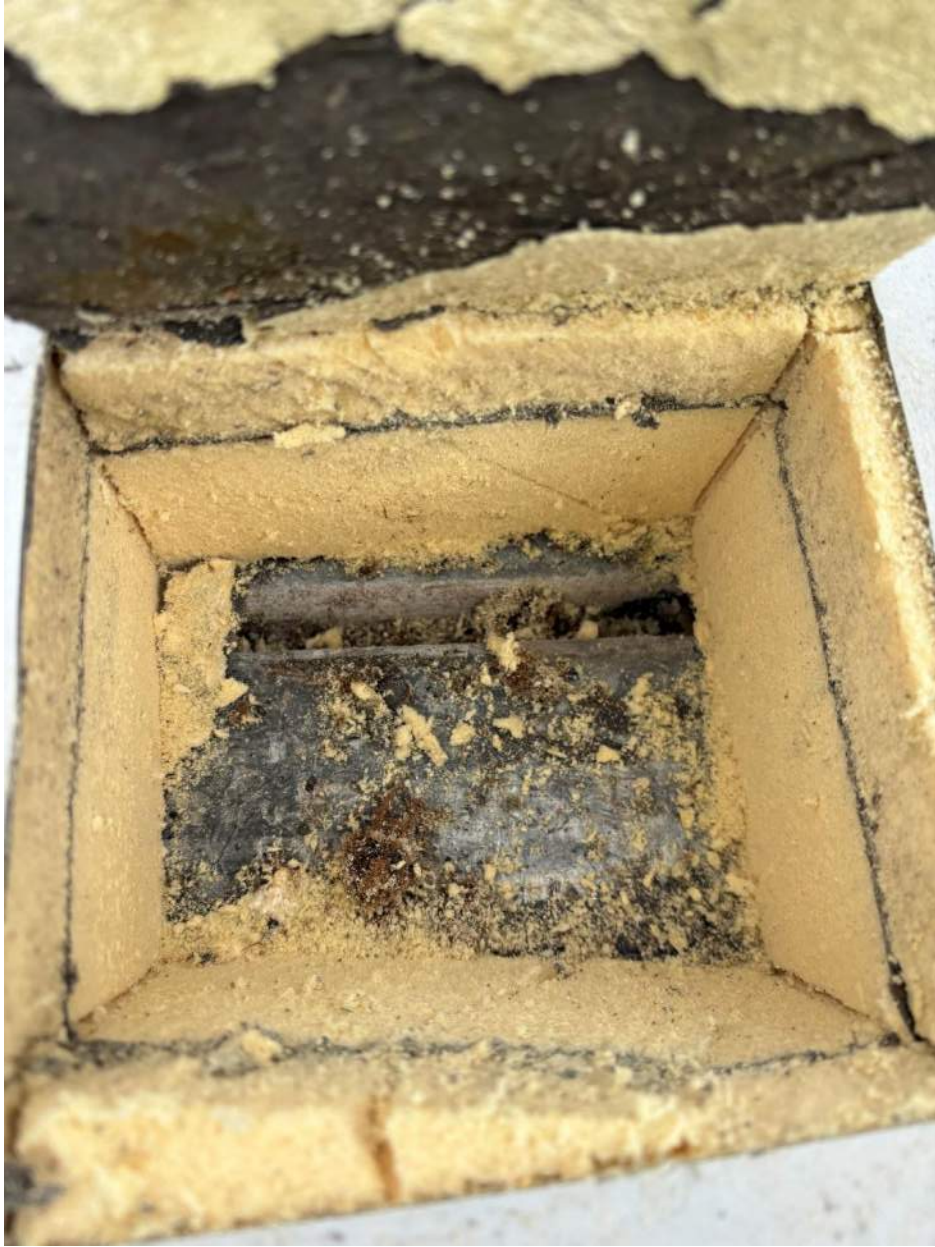
The last few photos show various roof cores on the main school roof. As shown tar does not cover the entire roof. In two locations (roof cores) the tar was found to be positive for ACM.

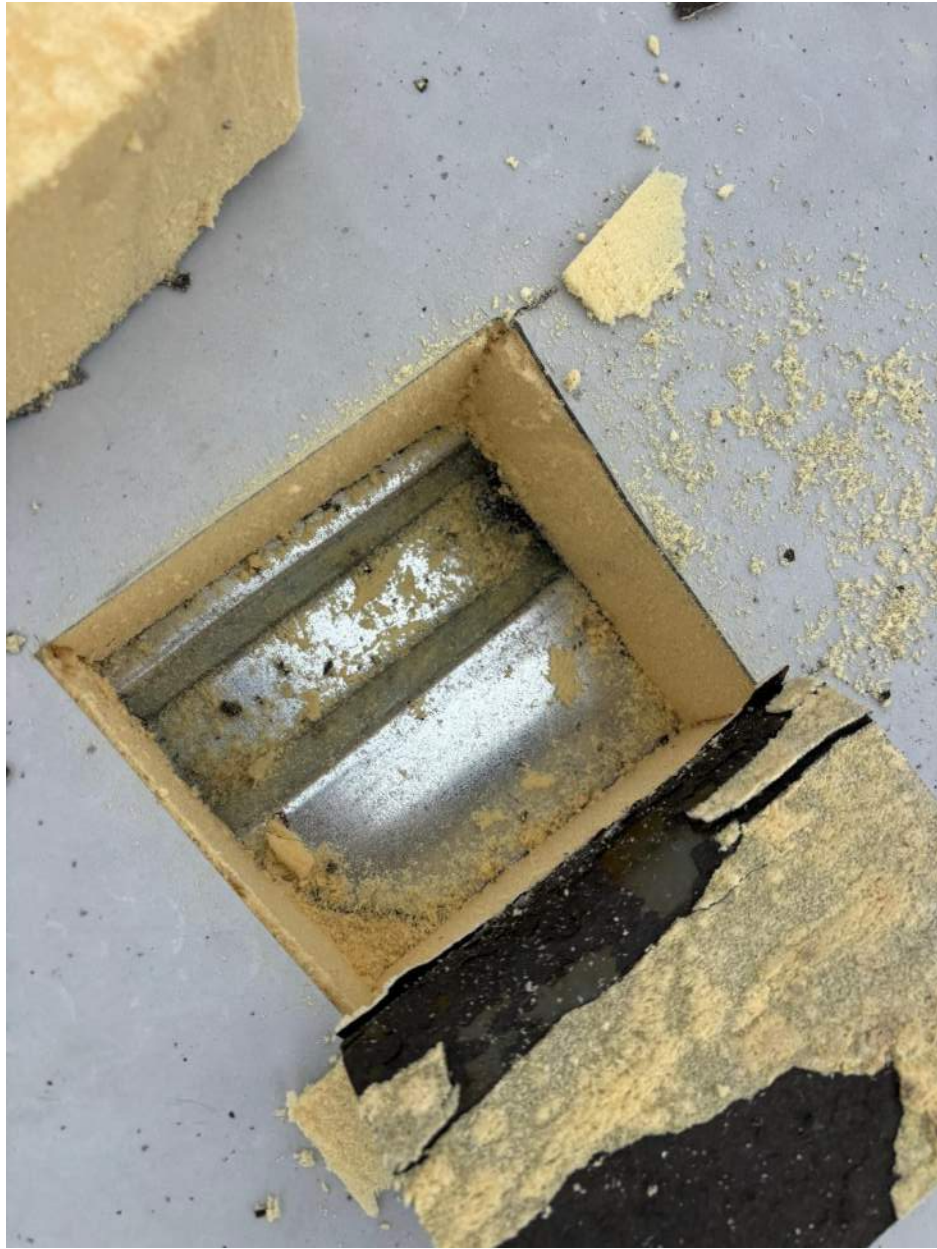
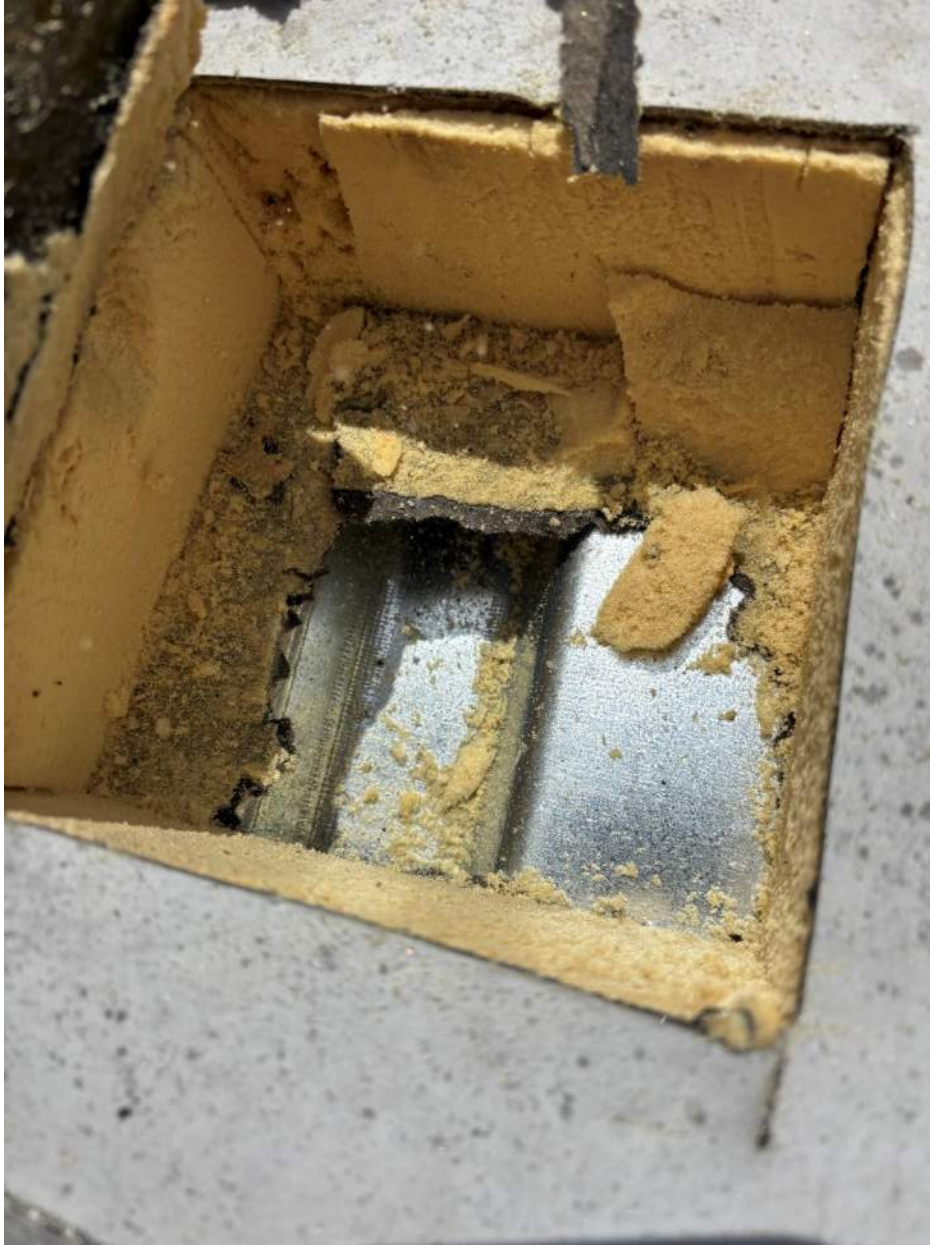
The last two photos show roof cores from the two roofs from the library to the main school. No tar was present on the metal deck.

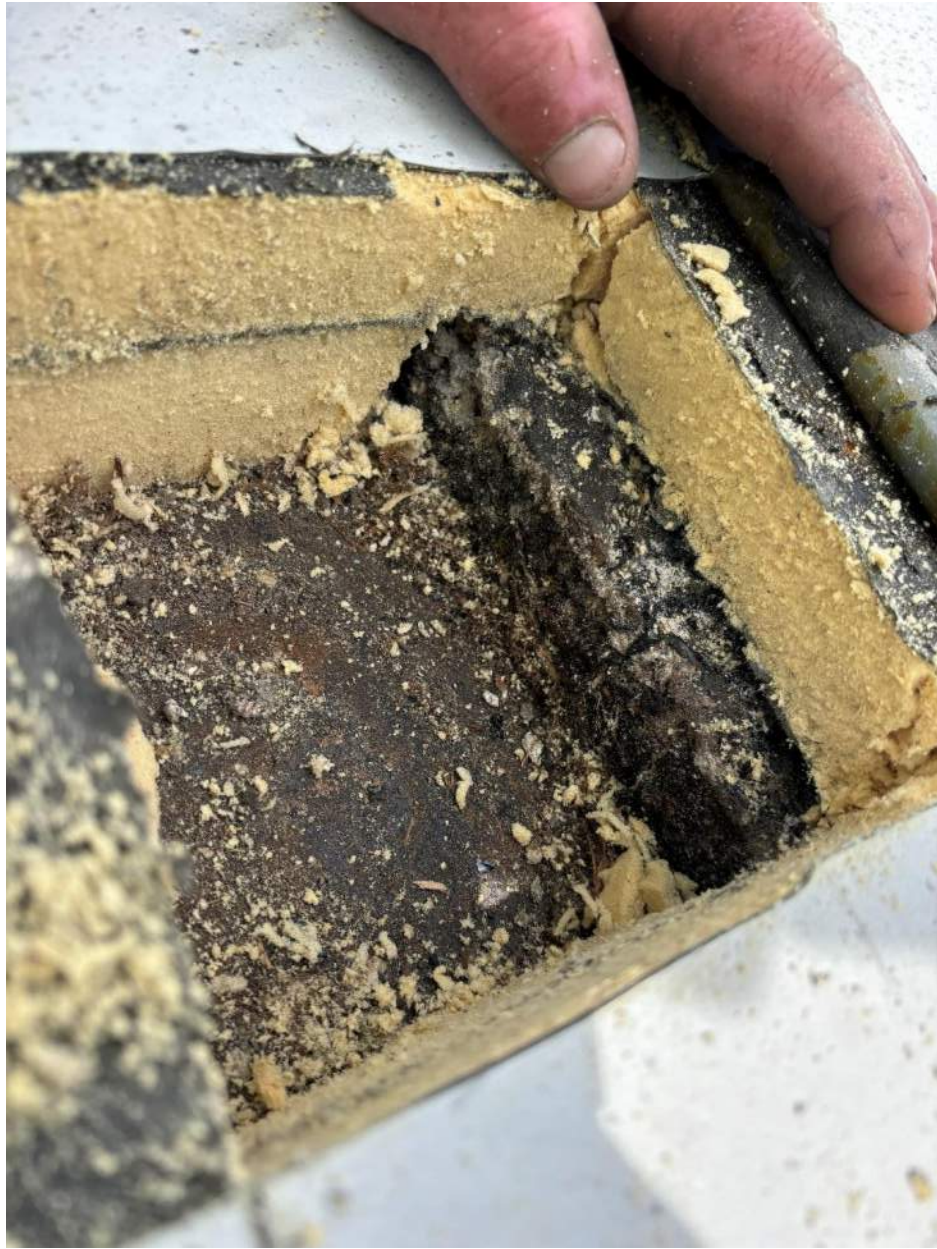
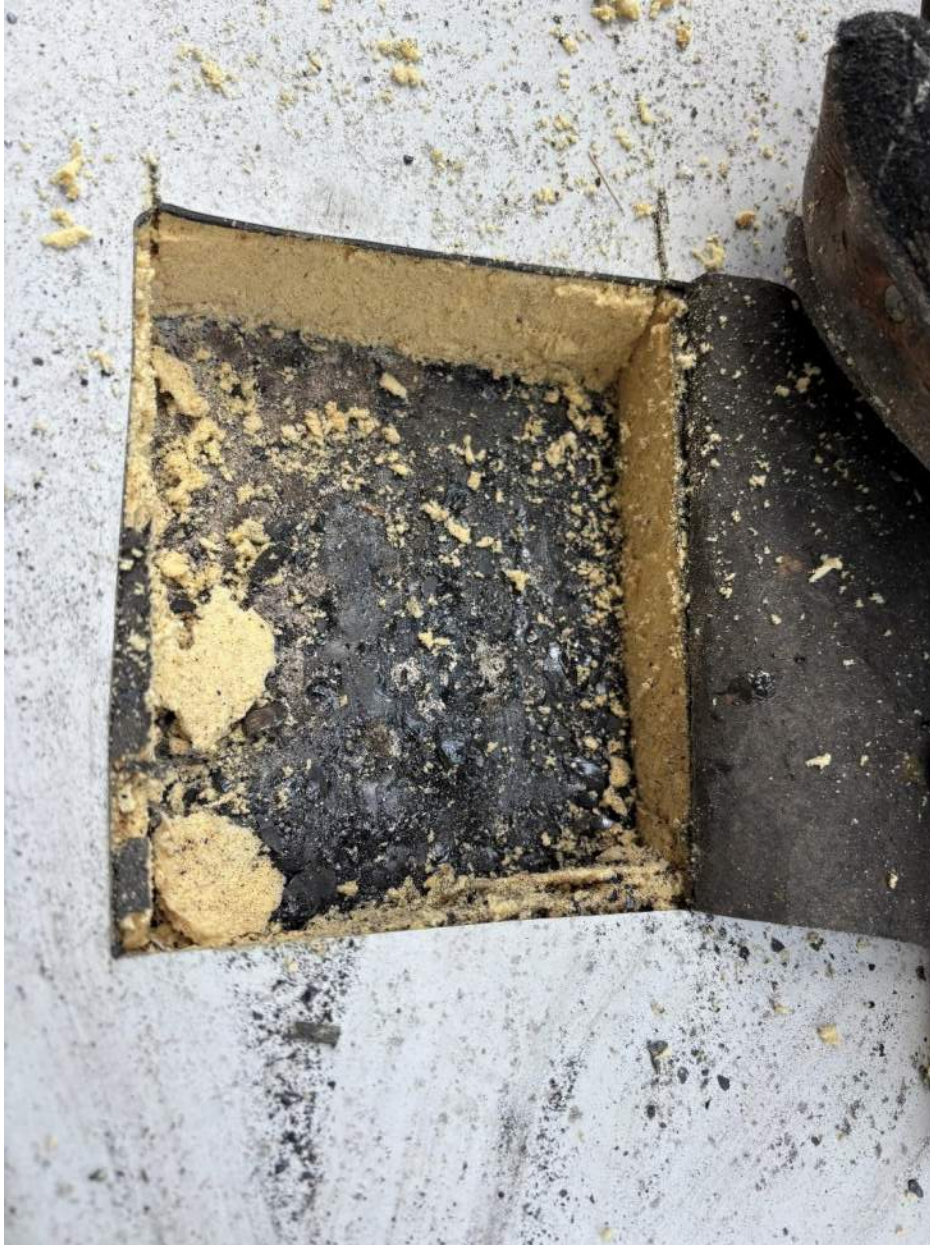
The last two photos show roof cores from the roof above the main school entrance. The tar is mopped on this roof. The roof deck is concrete. Samples collected reported no detection of ACM.
