## **HAZARDOUS MATERIALS SUMMARY REPORT**

### **Roof Replacement Project**

**Town Of Amherst  
Amherst Pelham Regional Middle School  
170 Chestnut Street  
Amherst, Massachusetts**

July 2025

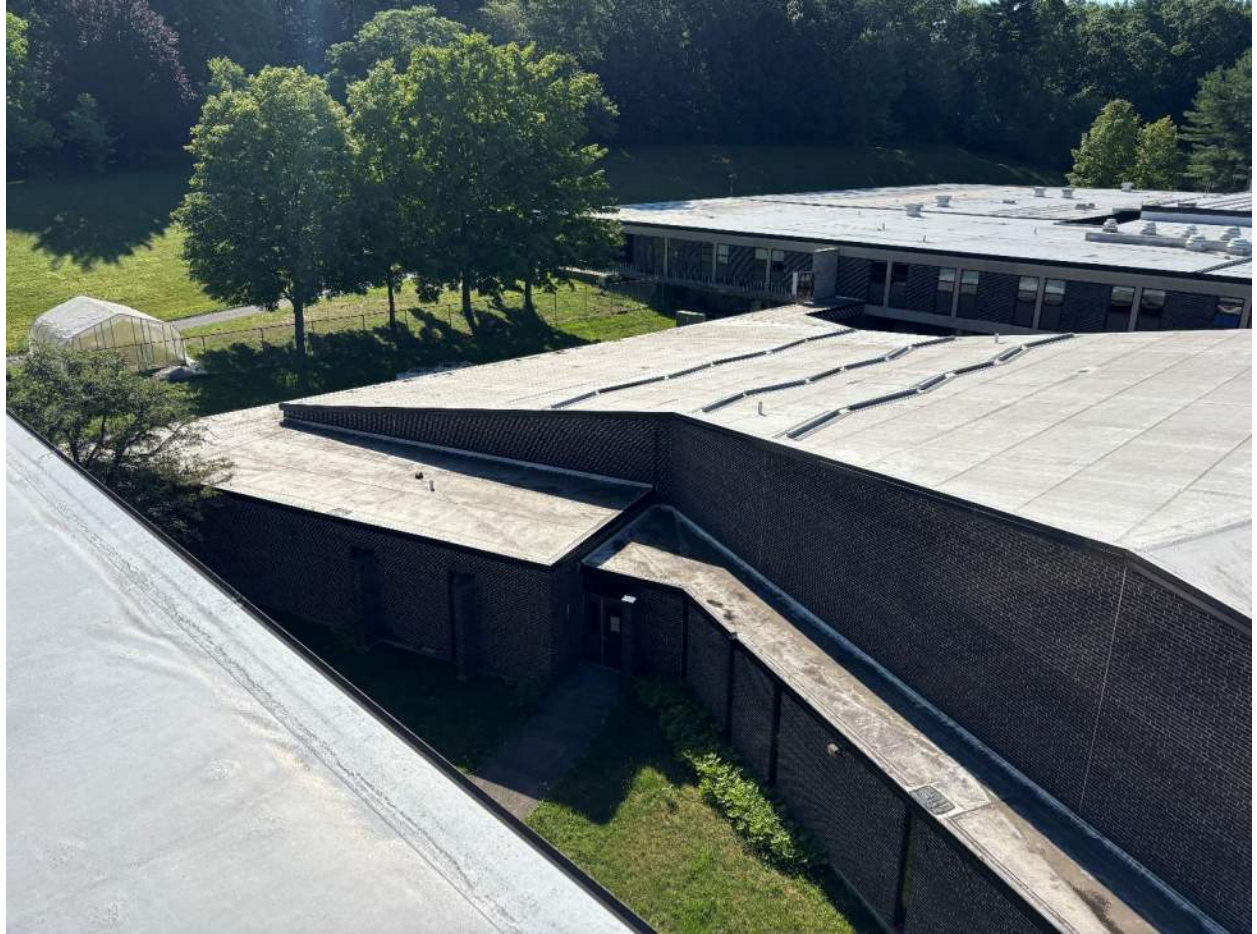
The gutter shown in this photo contains a Gray Sealant that is positive for ACM. (Gutters on either end of the auditorium roof)

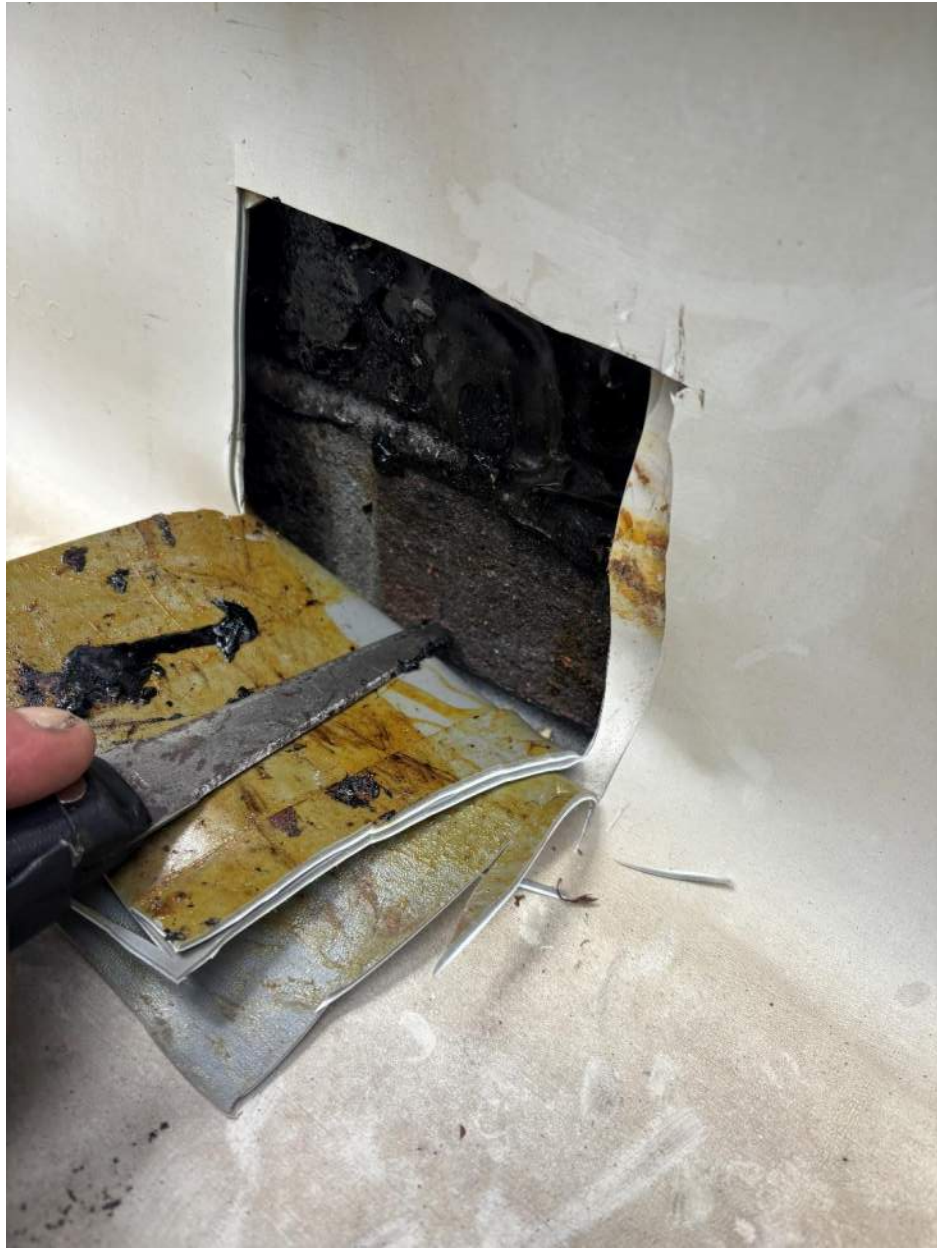
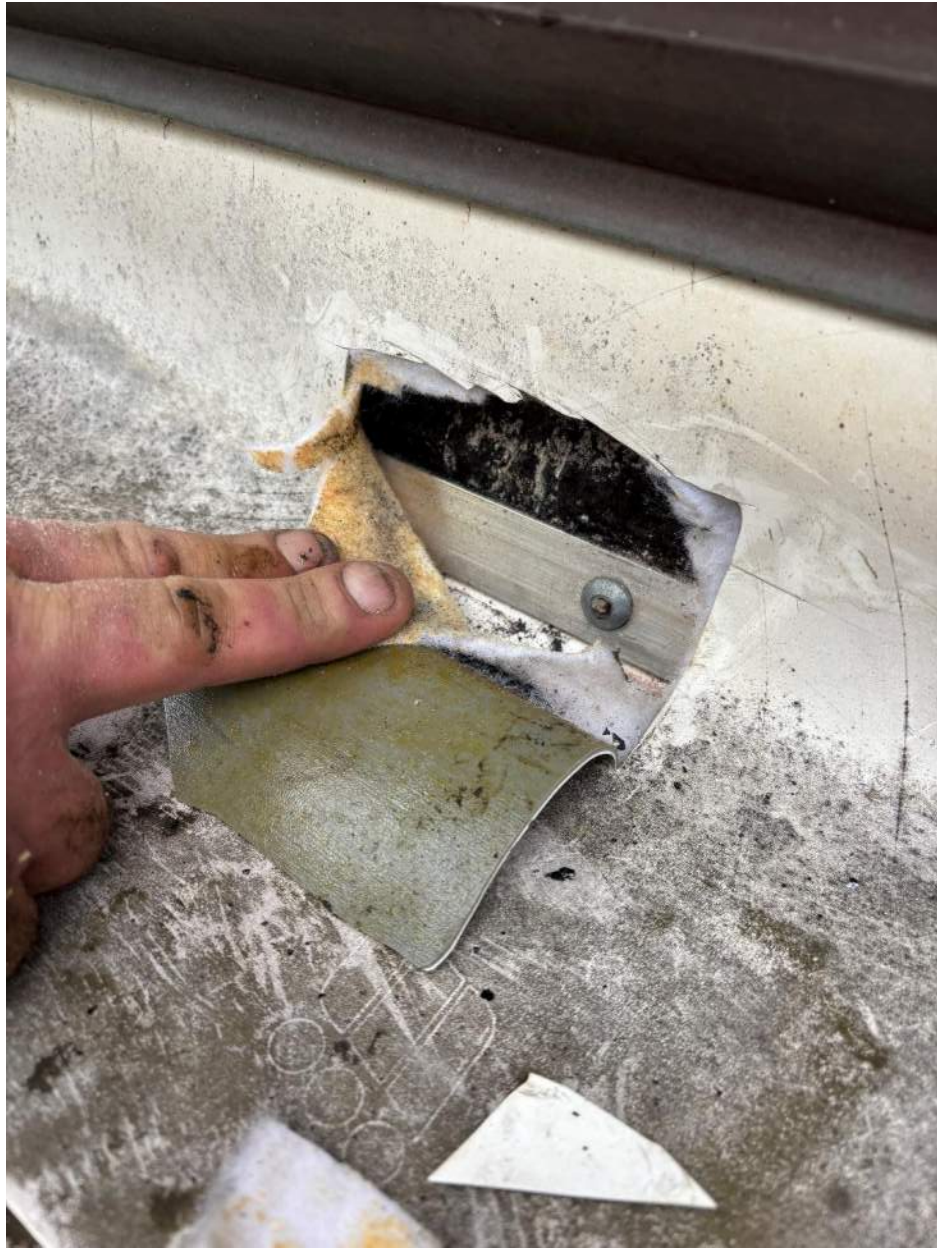
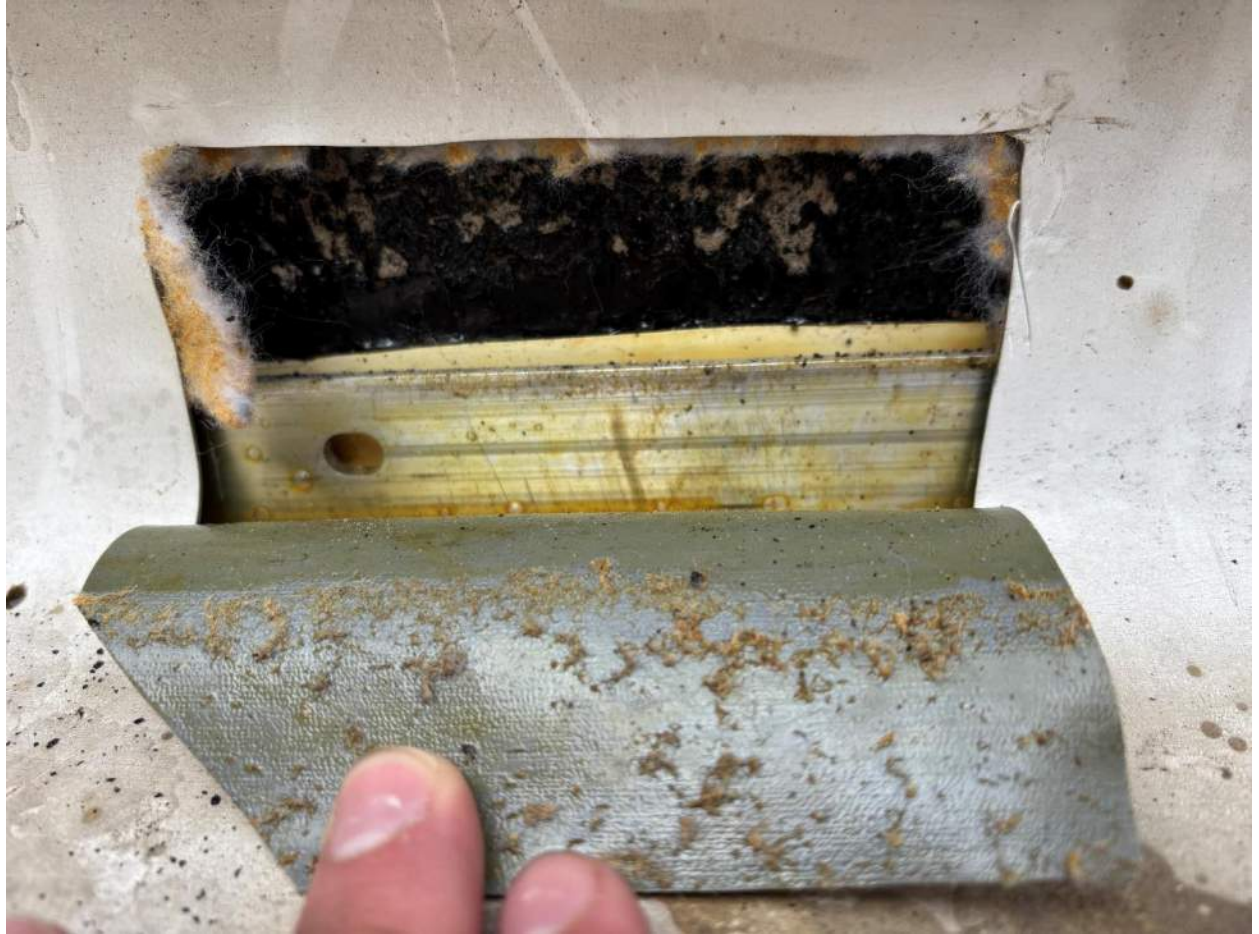
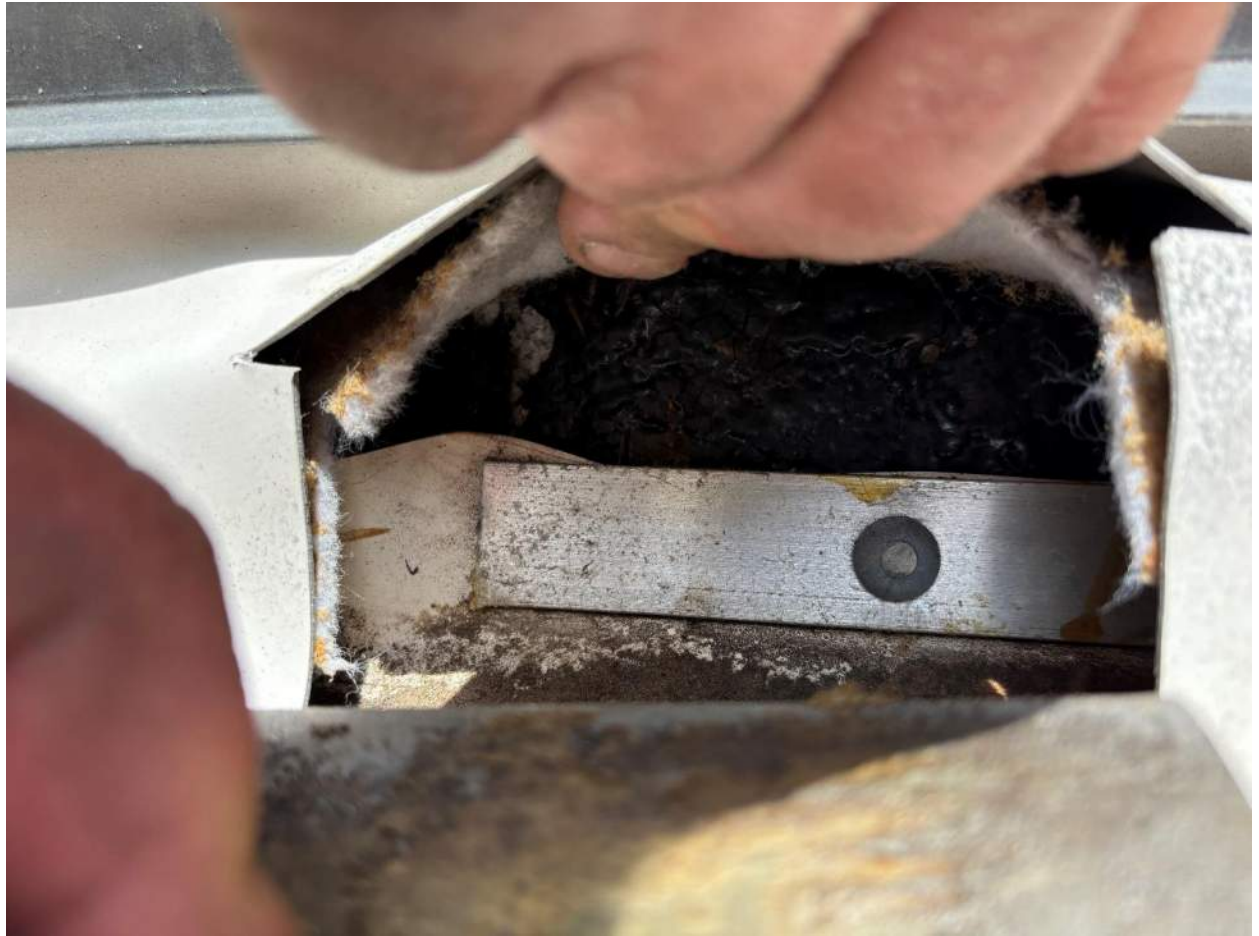
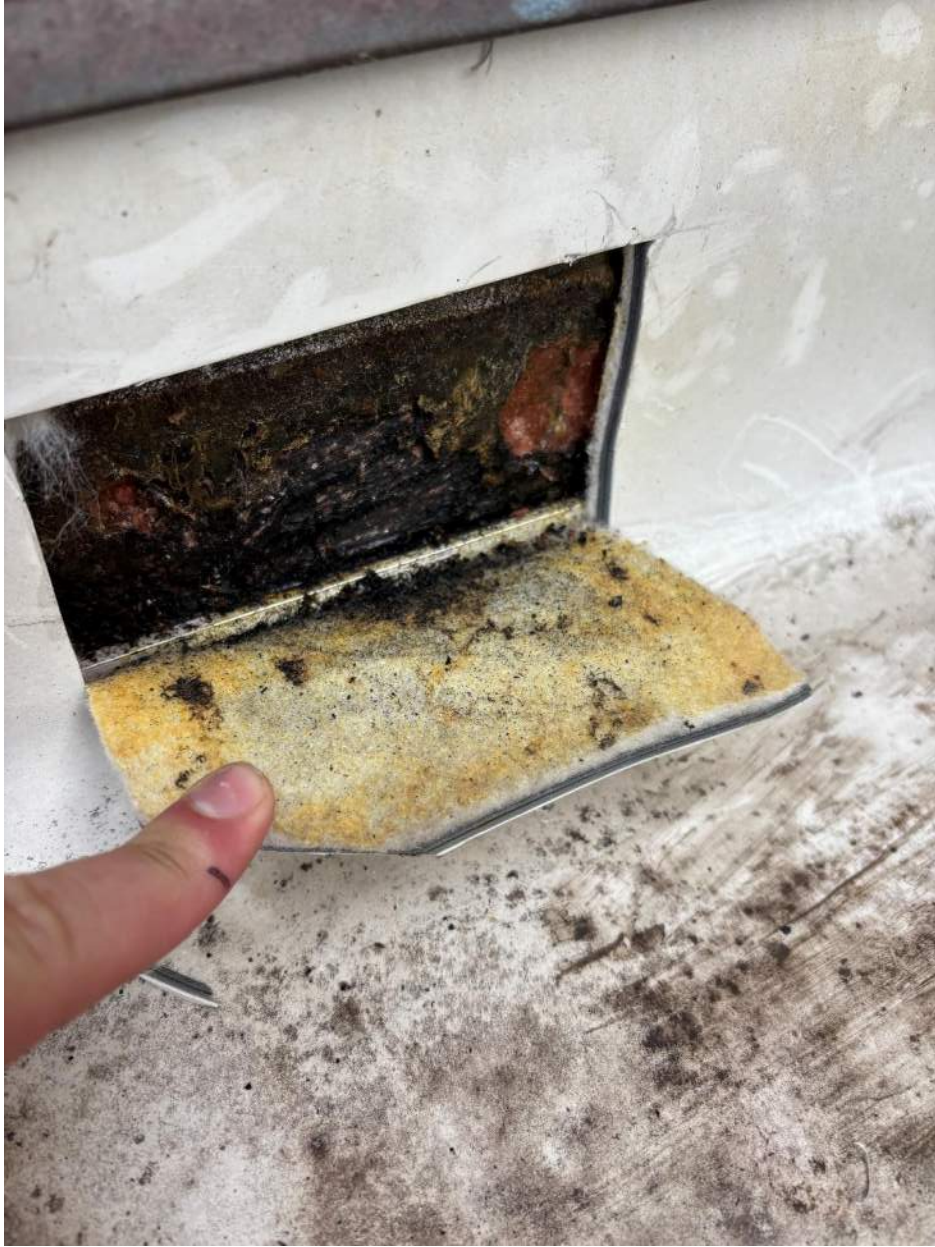
The last few photos show various curb cuts on the auditorium roof.

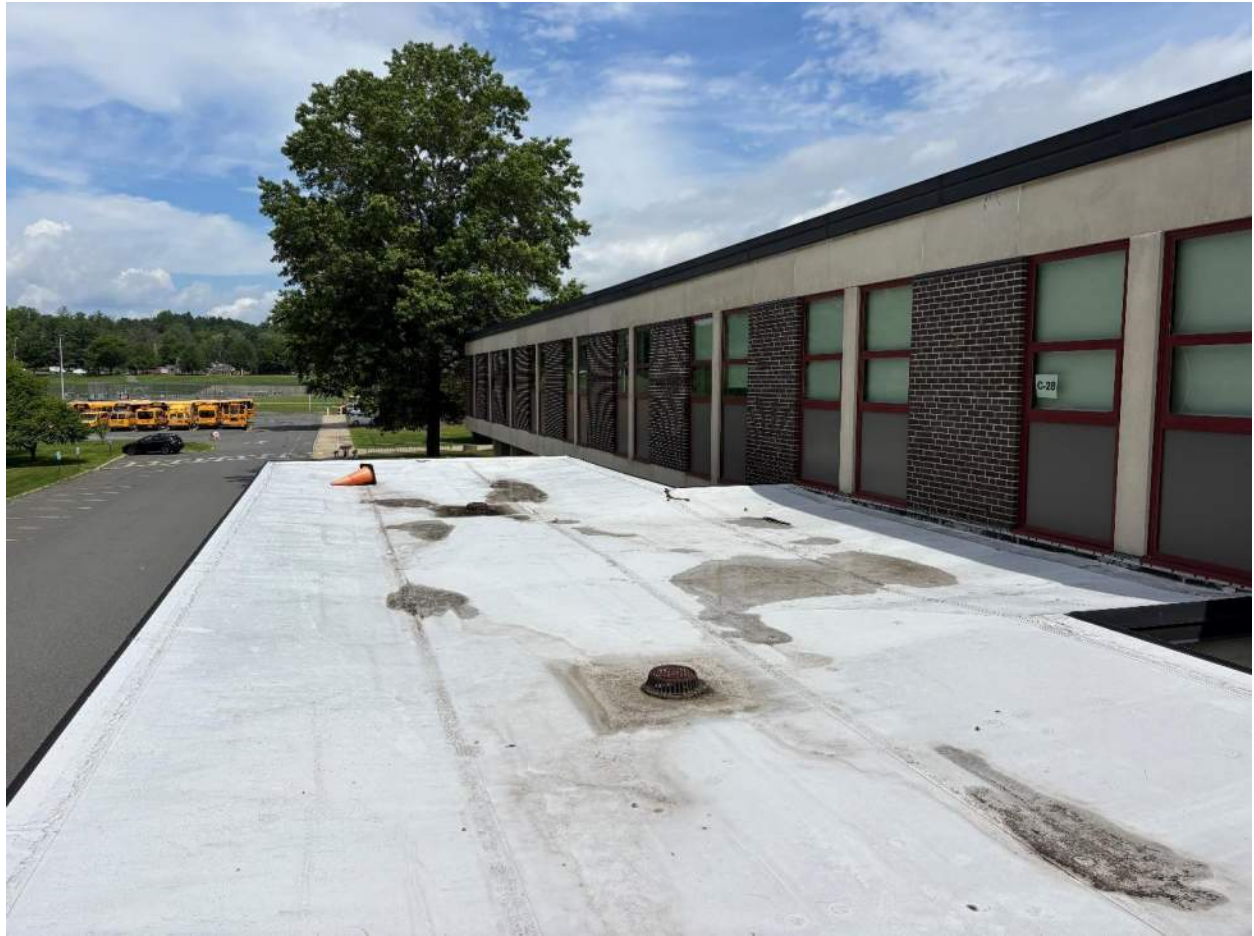
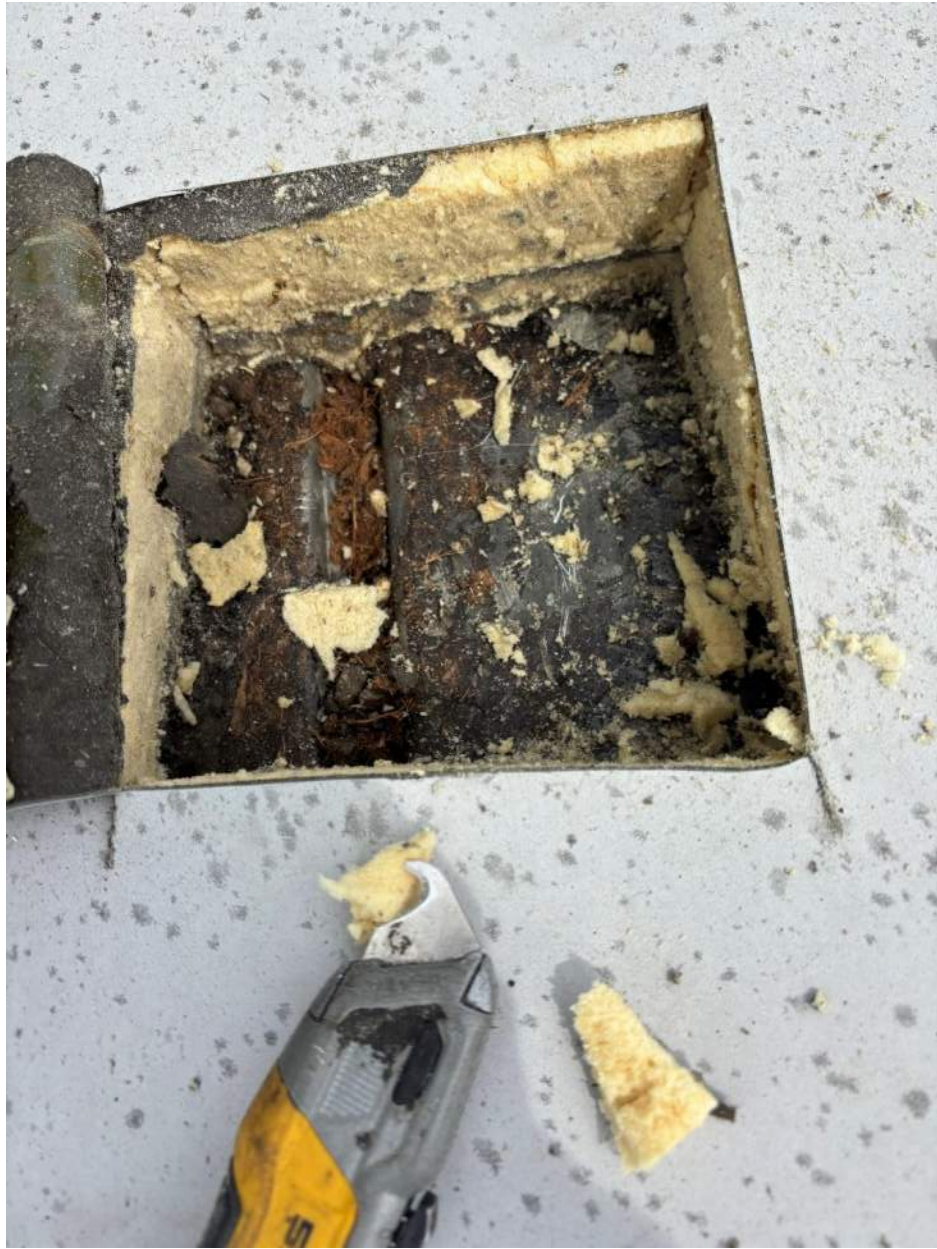
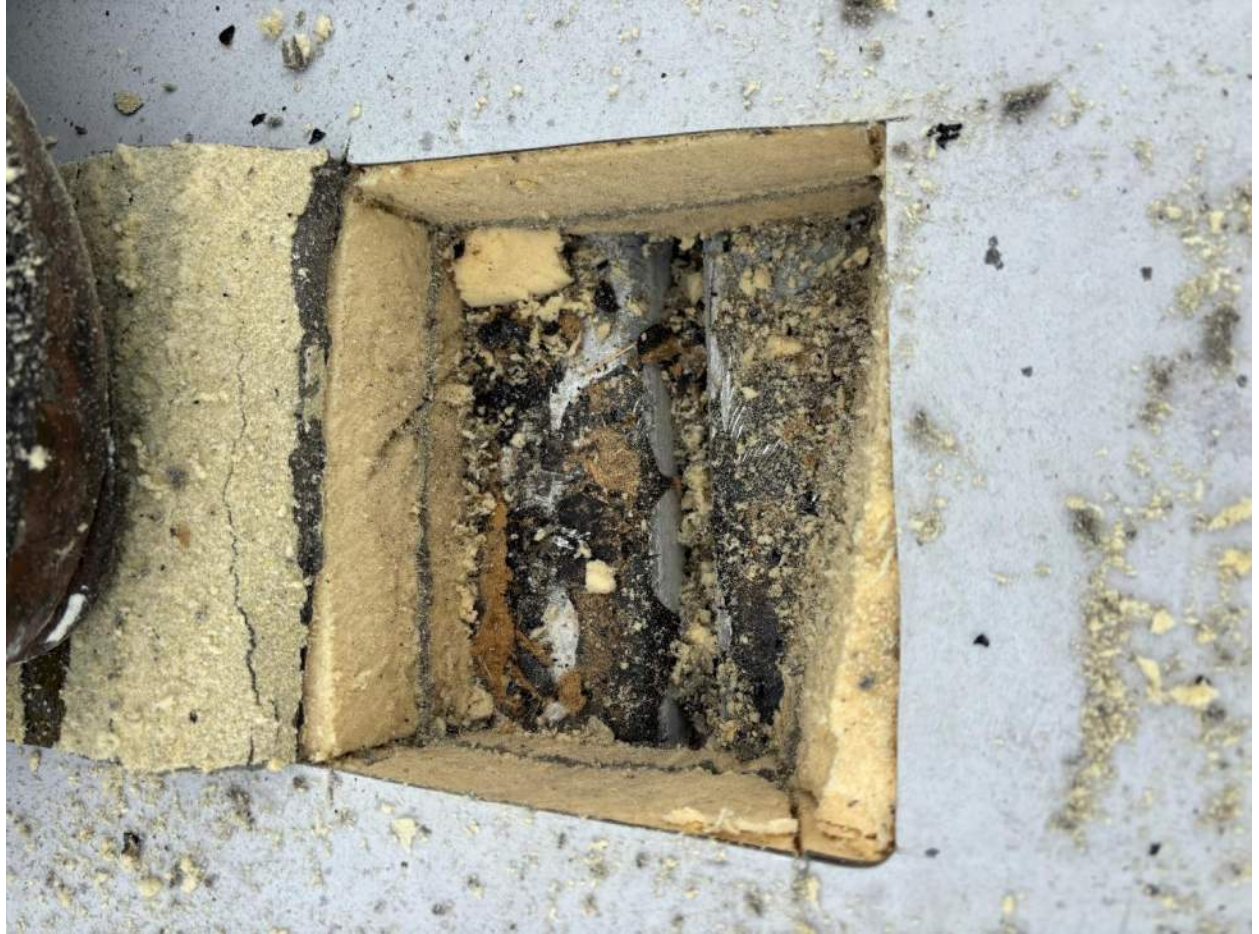
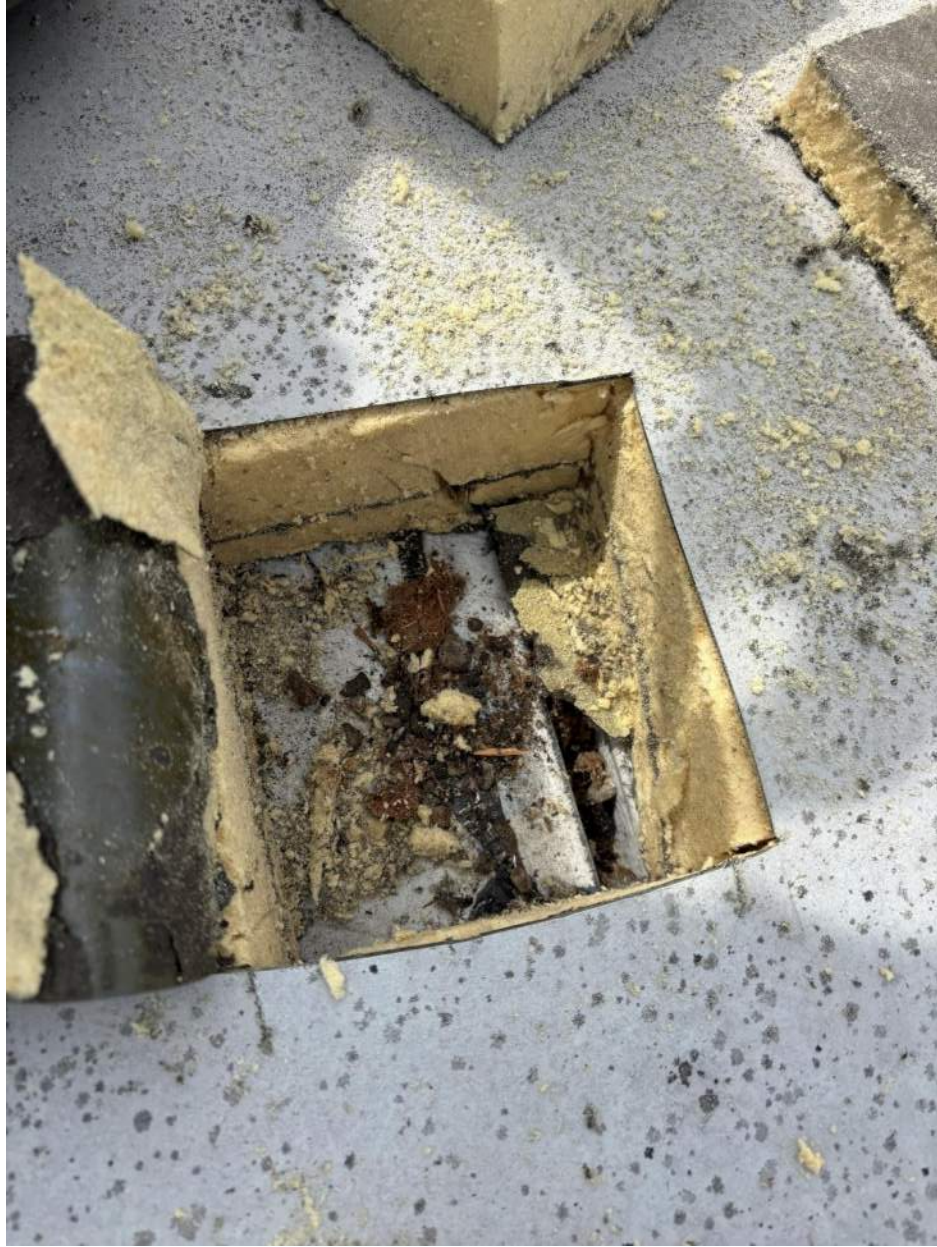
The last few photos show various roof cores on the main school roof. As shown tar does not cover the entire roof. In two locations (roof cores) the tar was found to be positive for ACM.
